November 2021

Ford Ranger/Raptor/Everest & Mazda BT-50 Battery Replacement

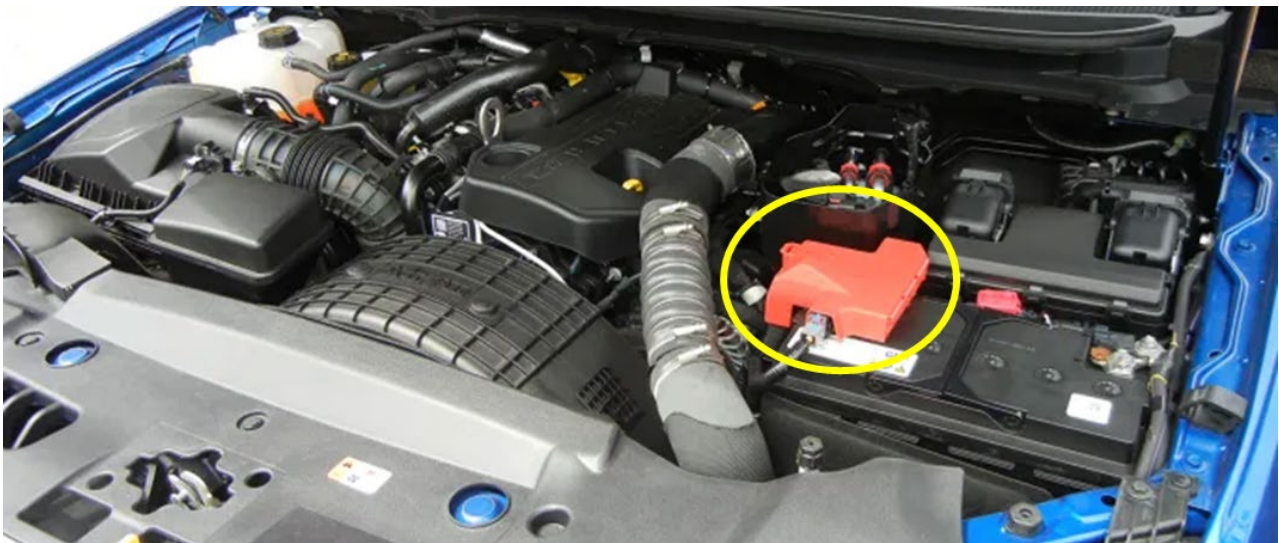
Late model Ford Rangers & Mazda BT-50's have a large power distribution block attached to the positive battery terminal (circled in yellow below). This block contains 2 fuses and a number of power take off points for the vehicle.

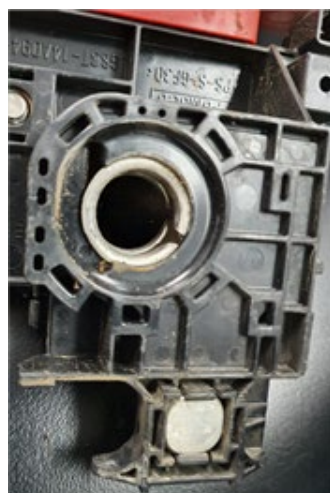
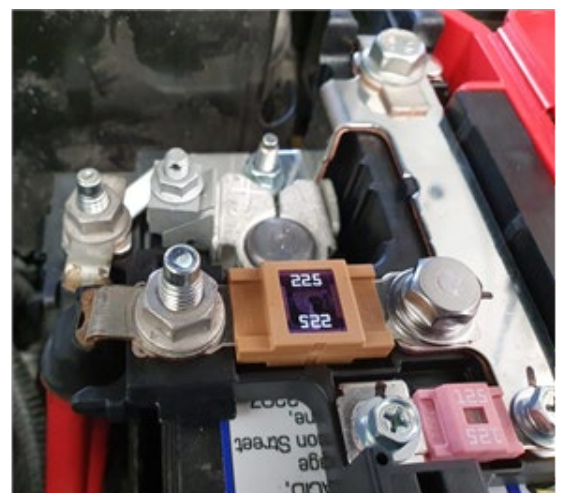
This block appears to be robust, and the M6 & M8 studs used also suggest this however the base structure is moulded from plastic. All of the studs are retained and located by the plastic base and are not designed for high torque loads. Unfortunately the nuts are often over-tightened which can cause cracks or a failure when removing them.

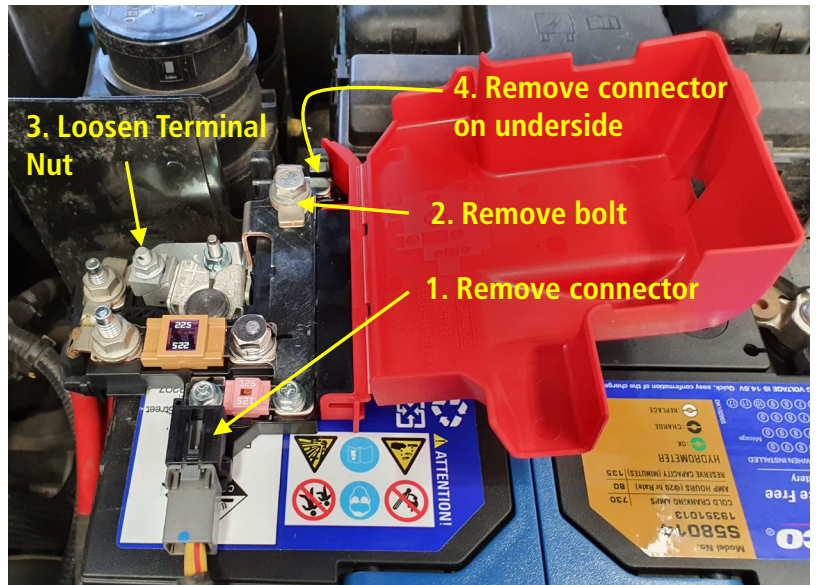
Figure 1 – Connection removal sequence

Fig. 1 details the connections which need to be removed using the number sequence shown.

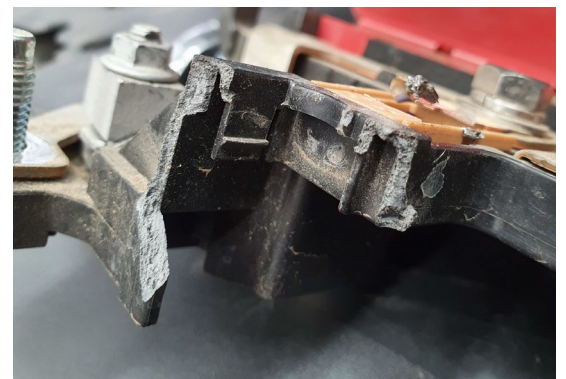
Figure 3 – Stud failure

Fig. 3 shows what can happen when the retaining nuts have been previously over tightened. In this case when the stud broke off it also destroyed the 225A Maxi Fuse.

This issue is well known by OEM dealers and the aftermarket service industry. The only solution when a failure occurs is to purchase a new Power Distribution Block from a Ford or Mazda dealer. The Ford part number is GB3Z 14526A, and it will cost around \$140.
